**SUPPLEMENT TO WATER COMPLIANCE INSPECTION REPORT FORM  
(EPA FORM 3560-3 (REV 9-94))**

**DNER DE DIEGO PUMP STATION, DE DIEGO STREET MSJ, PRASA,  
AND DTPW COLLECTION SYSTEMS**

Inspection Date: July 11, 2013

**DNER De Diego PS Drainage Area RI**

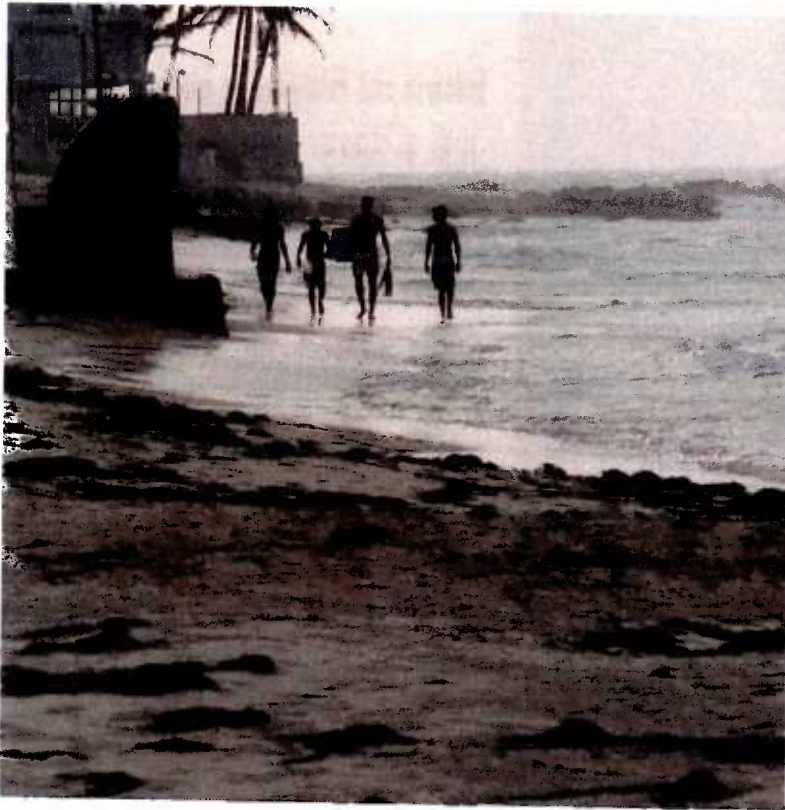
**Note:** Several individuals were observed walking near to the DNER De Diego PS Outfall at the Condado Beach.

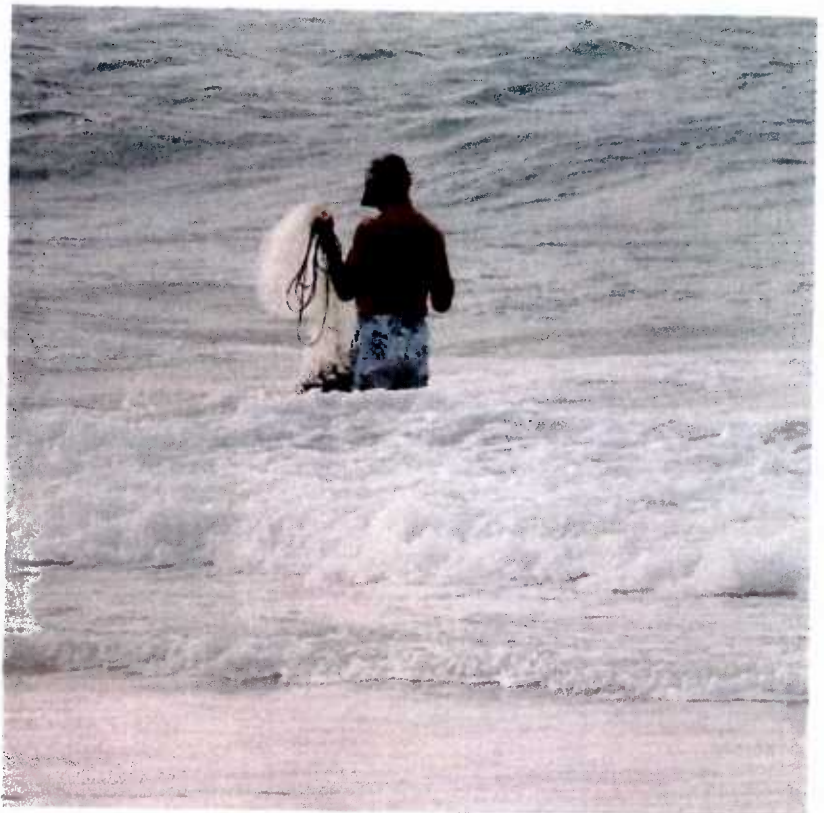
**DNER De Diego PS Outfall**

**Note:** An individual was observed fishing near the DNER De Diego PS Outfall at the Condado Beach.
